**Castle Street Medical Centre, Bolsover,
Derbyshire.
Archaeological Watching Brief.**

ARS Ltd Report 2013/3
January 2013

Castle Street Medical Centre, Bolsover, Derbyshire. Results of an Archaeological Watching Brief.

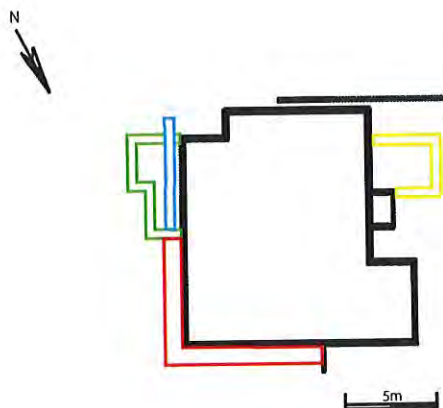
Site Code: Castle Street
Medical Centre
Figure: 3
Date: 1st February 2013

Overall site plan
Scale: 1: 500

— Trench 1
— Trench 2
— Trench 3
— Trench 4

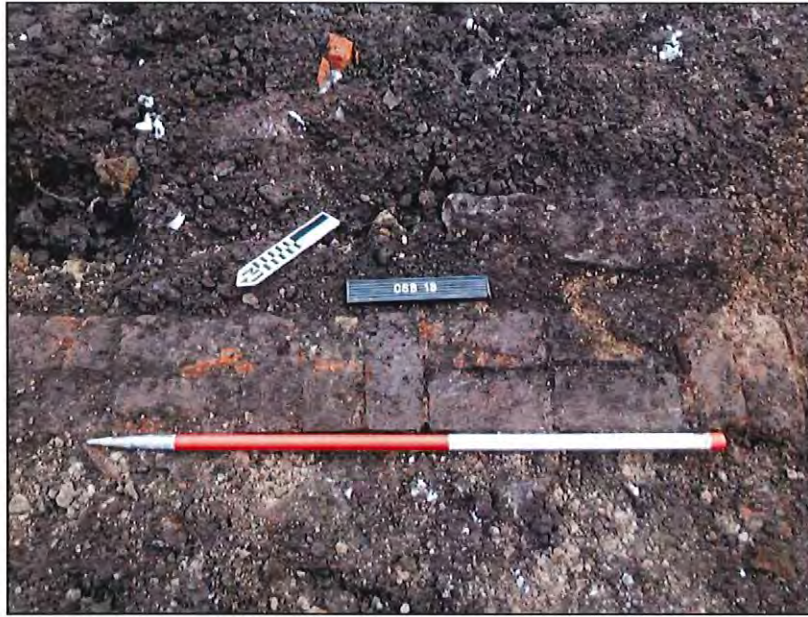
Figure 4. Wall (103), showing upper course of bricks

4.1.2 Pale yellow sandy gravel (101) containing a modern ceramic drainpipe with plastic fittings was observed cutting through the topsoil at the south-western end of the trench. This deposit was clearly associated with the initial construction of Castle Street Medical Centre and abutted foundation [102] which contained a brick wall and associated bedding (103). The upper surface of the wall was approximately 0.15m below the current ground surface in topsoil (100), and was aligned approximately north-east to south-west, made of plain, unfrogged, handmade bricks 0.23 by 0.08 by 0.11m with a dry crumbly sandy bond. The wall consisted of three courses of brick and was constructed upon a bedding of flat sandstone slabs. The full depth of the bedding slabs was not reached within the confines of the excavation, but extended at least 1m beneath the bricks. The alignment and location of this wall matches the documented position of the Congregational Chapel, and the exposed wall is comparable to that exposed during the 2009 investigation (Marshall 2009), which was positively identified as part of the Congregational Chapel.

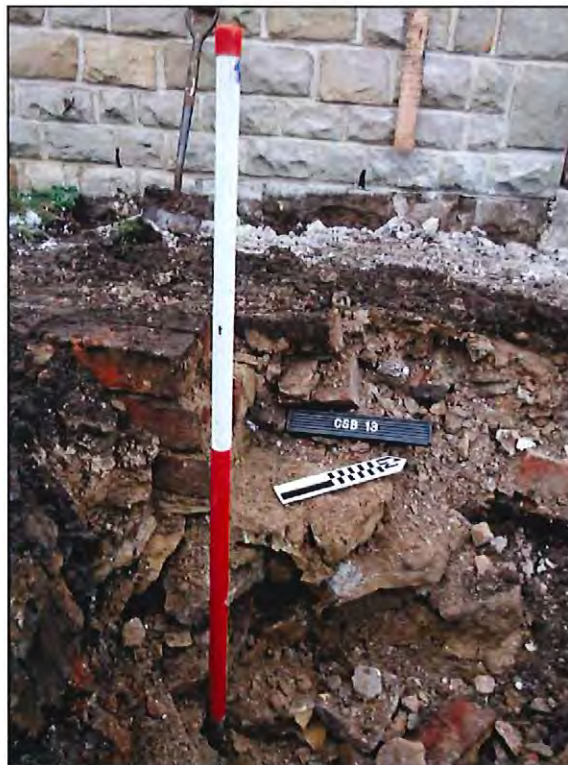
Figure 5. Wall (103), showing bricks and sandstone slab bedding

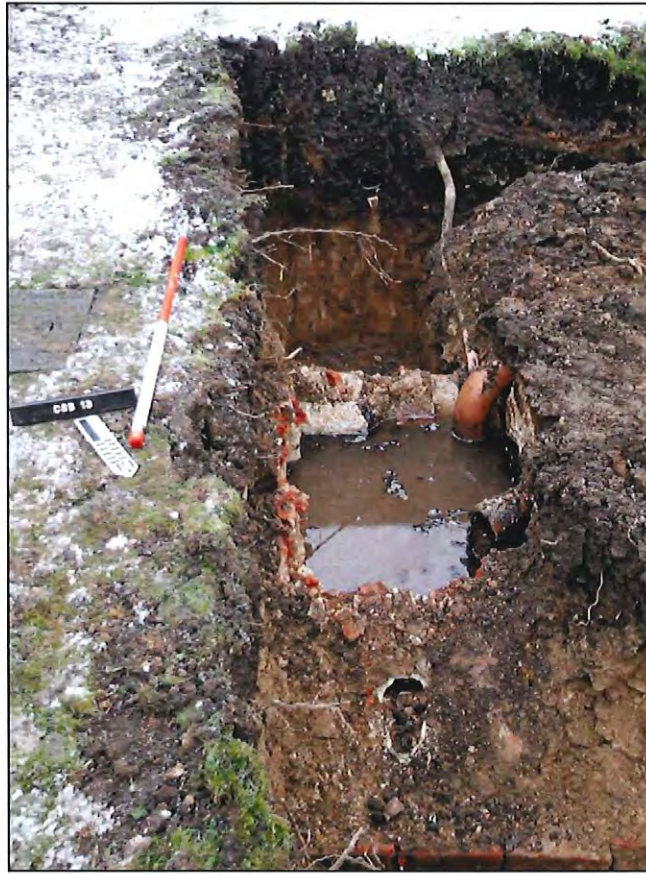
Figure 6. Cistern (105). Note the lead pipe running from the back of the cistern which was once probably attached to a water pump. The section into which the lead pipe runs contains topsoil (100) and natural (106).

4.1.3 Cut [104] contained cistern (105), a structure of plain unfrogged handmade bricks, 0.23 by 0.11 by 0.08m in a dry crumbly sandy bond. The structure was not fully revealed, but consisted of straight sides with a domed roof, containing water. The internal depth was not fully revealed but exceeded 2m. A lead pipe ran out of this structure towards buildings to the south-west, and modern land drain seen in (101) also fed into it. The handmade bricks and lead pipe suggest that this cistern was once used as a water supply to nearby houses, probably 19th century in date, which became disused after the town was connected to mains water supply. It is likely that whilst constructing the current Castle Street Medical Centre, the modern drain observed in (101) was connected to the cistern as a means of drainage.

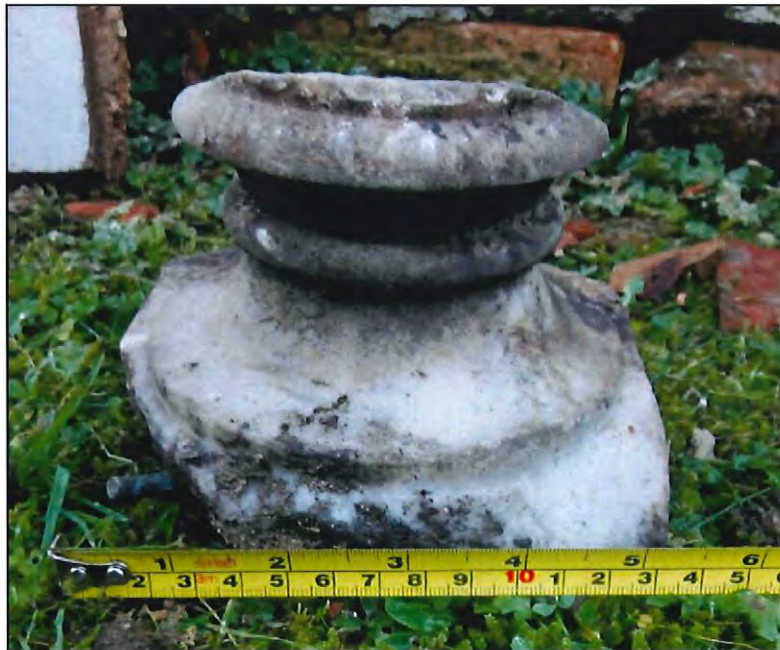
Figure 7. Grave monument recovered from (106)

4.1.4 Deposit (106) was homogenous orange brown silty clay of natural appearance and texture. The deposit had clearly been subject to disturbance as both wall (103) and cistern (105) was cut into it. In addition, modern building debris was found to be scattered throughout the deposit, including plastic sheeting, modern bricks and polystyrene. Part of a grave monument was also found in this deposit in a particularly dense concentration of building debris, which is likely to be from the graveyard of the Congregational Chapel; headstones could still be observed within extremely close proximity to the trench and it is likely that this grave monument became disturbed during

the initial construction of the Castle Street Medical Centre and became mixed in with building debris that was being used as a backfill. Deposit (106) is likely to represent disturbed/redeposited natural material that has been disturbed numerous times during the construction of the chapel, represented by wall (103), and also cistern (105) and the current Castle Street Medical Centre. Irregular bands and patches of this type of deposit could be observed in topsoil (100); it is very likely that such material is the same as (106), and has become mixed with the topsoil during the prolonged activity and disturbance in the investigation area.

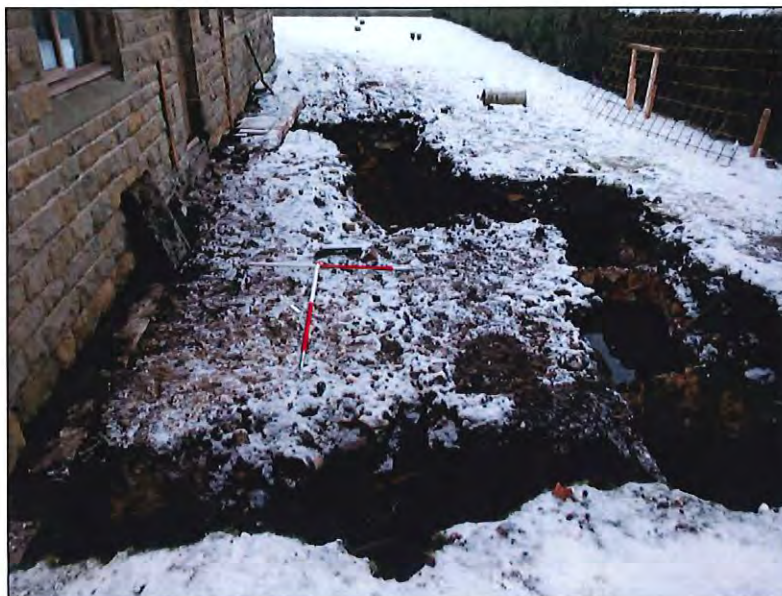
Figure 8. Trench 1 fully excavated

4.1.1 Following turf removal, the first deposit encountered was dark grey brown clay silt topsoil (100) with frequent root and worm presence. This deposit was present throughout the whole of the investigation area at a fairly uniform depth. The maximum thickness of this deposit was 0.90m and the minimum thickness was 0.62m. The deposit displayed clear evidence of being disturbed, probably multiple times, with modern levelling deposit (101) and numerous land drains, mostly associated with Castle Street Medical Centre, cut into it. One sherd of post-medieval pottery and 3 fragments of clay pipe all dating to the early 18th century (appendix 1) were recovered from this deposit, along with some modern objects such as: plastic sheeting, machine-made frogged bricks and polystyrene. Bands of orange clay material, very similar to (106) were also present, in irregular and infrequent horizontal bands, indicating that much of this investigation area has been subject to disturbance.

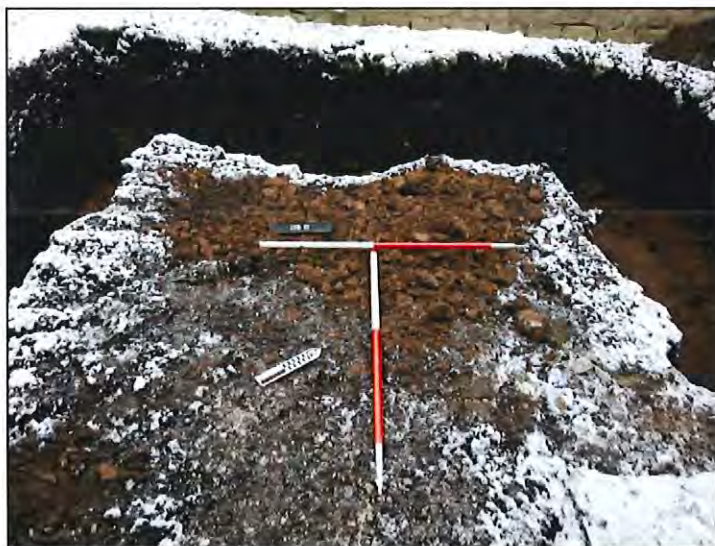
Figure 11. Trench 2 fully excavated

4.2.1 After turf removal the first deposit encountered in trench 2 was dark grey brown silty clay topsoil (107), extremely similar to that encountered in trench 1. Given the close proximity of the trenches, (100) and (107) are highly likely to represent the same deposit. Evidence of recent disturbance was apparent with scattered inclusions such as brick, plastic sheeting, polystyrene, foam insulation and glass.

4.2.2 Deposit (108) lay directly beneath the topsoil (106) and comprised orange brown slightly silty clay. Although of natural appearance and texture, this deposit has clearly been recently disturbed, probably during the initial construction of Castle Street Medical Centre, with abundant building debris such as wire mesh, modern bricks and plastic sheeting in scattered patches throughout. This deposit was extremely similar to (106) in trench 1 and the two are highly likely to represent the same deposit, being disturbed/redeposited natural material.

4.2.3 No archaeological features or finds were encountered in this trench.

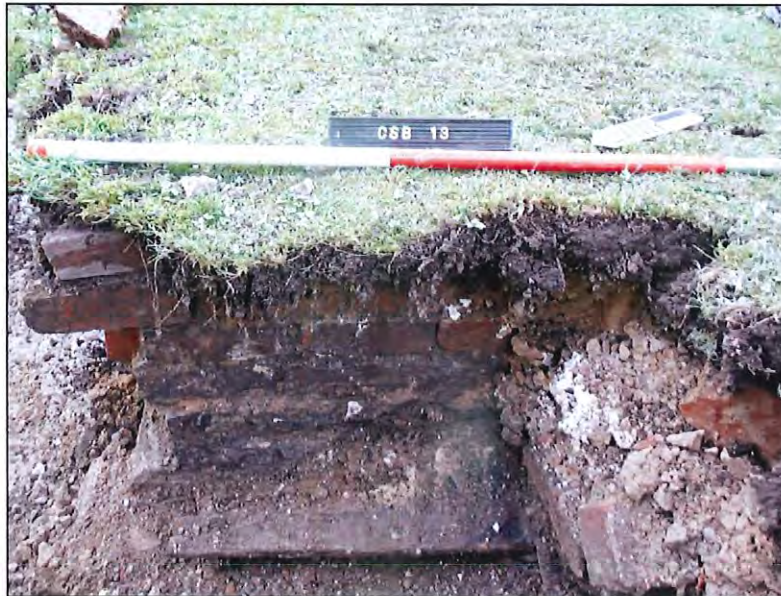
Figure 14. Inner edge of wall (103) and rubble/demolition layer (109) to the right. Note also the wooden plank at the base of the rubble layer in the centre bottom of the picture.

4.3.2 Deposit (109) was directly beneath topsoil (100) and abutted wall (103) as discovered in trench 1 at the south-western edge. Deposit (109) was positioned on the inner edge of wall (103), placing it inside the walls of the chapel. The deposit contained what appeared to be a layer of dumped building material, or a building demolition layer; a number of bricks were present, but displayed no structure or form in their arrangement. The bricks in this deposit were identical to those in wall (103) being plain, unfrosted and probably hand-made. Various finds of a structural nature were discovered within this rubble layer, including eleven rounded headed, square shafted nails, probably copper, 0.03m in length, along with two fragments of glass and two heavily corroded iron nails. Directly underlying the bricks were some wooden planks, lying horizontally although somewhat randomly positioned with no uniformity. The largest plank measured 0.60 by 0.07 by 0.02m, with most examples being considerably smaller, although as all the planks were in poor condition it may be that some have eroded away. Within the confines of the excavation and considering the possibility that some of the wood may have eroded away it could not be determined whether these planks were *in situ* or if they too have been disturbed or redeposited. Modern building deposit (101) observed in trench 1, associated with the current Castle Street Medical Centre, abutted deposit (109) on the south-western edge. It seems likely that rubble deposit (109) may be a continuation of wall (103), and was heavily disturbed during the initial construction of Castle Street Medical Centre, and was either left in a disturbed state, or was taken out and redeposited as a backfill.

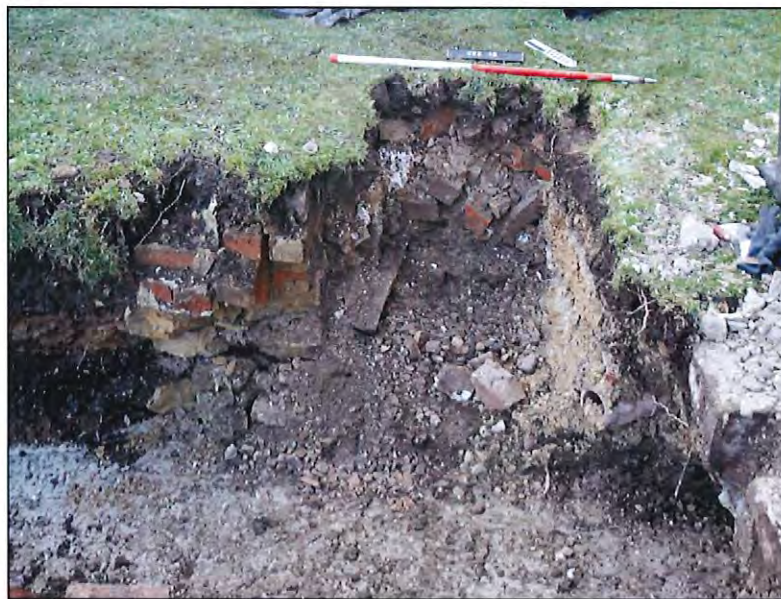
Figure 15. Wall (103) on the left and rubble/demolition layer (109) on the right, with modern building deposit (102) on the extreme right.

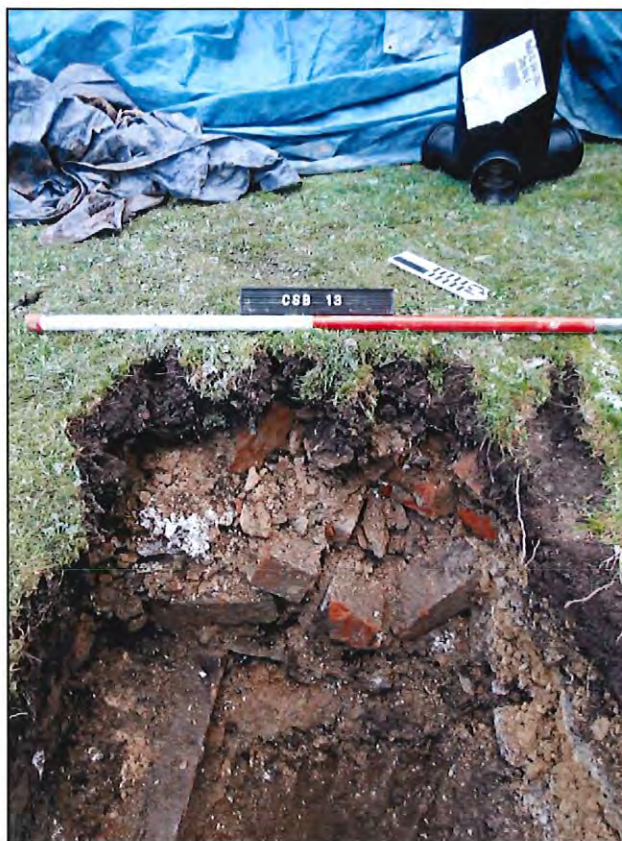
Figure 16. Rubble deposit (109) overlying layer (110).

4.3.3 Directly underlying (109) was (110), very compact dark grey brown clay silt with some sand, frequent small CBM fragments and frequent clinker type material. This deposit appears to be inside the wall of (103), and its upper surface is comparable to that of wall (103) at the foundation slab and brick structure interface. Given the compactness of this deposit, the frequent CBM and clinker inclusions and its relationship to the wall and slab foundations, it is possible that (110) represents a levelling surface for the floor of the chapel.

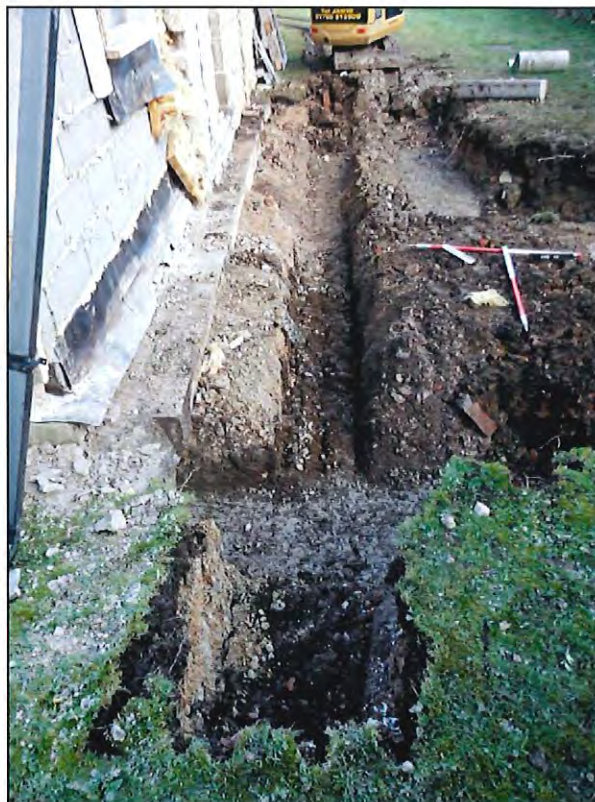
Figure 17. Trench 3 fully excavated.

4.3.1 After the partial concreting of trench 1, trench 3 was opened to allow for the insertion of a land drain, and was aligned approximately south-west to north east, cutting through trench 1 at the south-western end and abutting it at the north-eastern end. The first deposit to be encountered was, the topsoil deposit (100) encountered in trench 1.

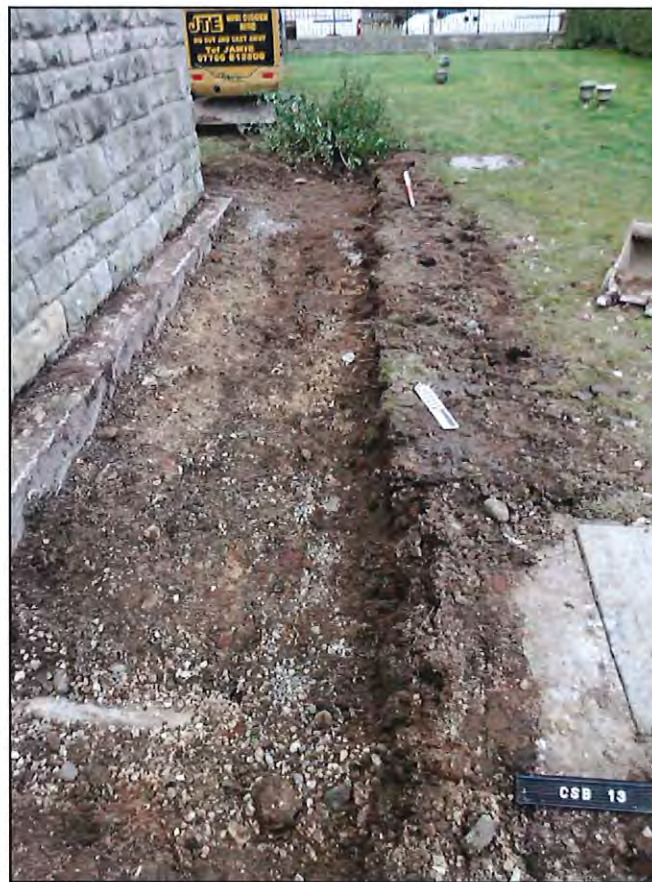
Figure 19. North-east / south-west alignment of trench 4 fully excavated

4.4.1 Trench 4 was aligned in a north-east to south-west direction, beginning at the north-eastern end of trench 1 and running along side the current Castle Street Medical Centre building for approximately 8m before turning at a right angle in a north-westerly direction in accordance with the form of the building, and continuing for a further 10 metres. This trench was opened in order to lay the foundations for a footpath, and as such had a maximum depth of 0.30m. The only deposit encountered throughout the entire trench was topsoil (100), with patches of (101) along the edges of the trench that were situated to the building.

4.4.2 No archaeological features or finds were encountered in this trench.

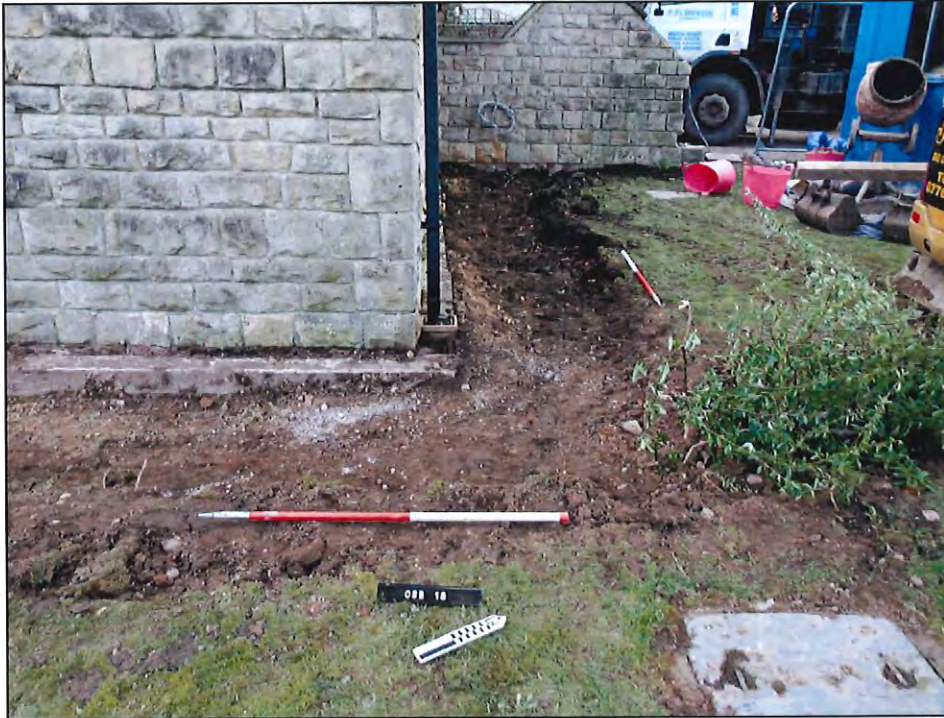
Figure 20. Trench 4 fully excavated
